Site Classification for Proposed Residential Development Lot 5, Argentia, Palm Cove Report Reference PGC0318016

This report by Phi Ground Innovations (PGI) summarises the results of a site classification investigation for a proposed residential development at Lot 5, Argentia, Palm Cove. The work was commissioned by Kerdic Homes Pty Ltd.

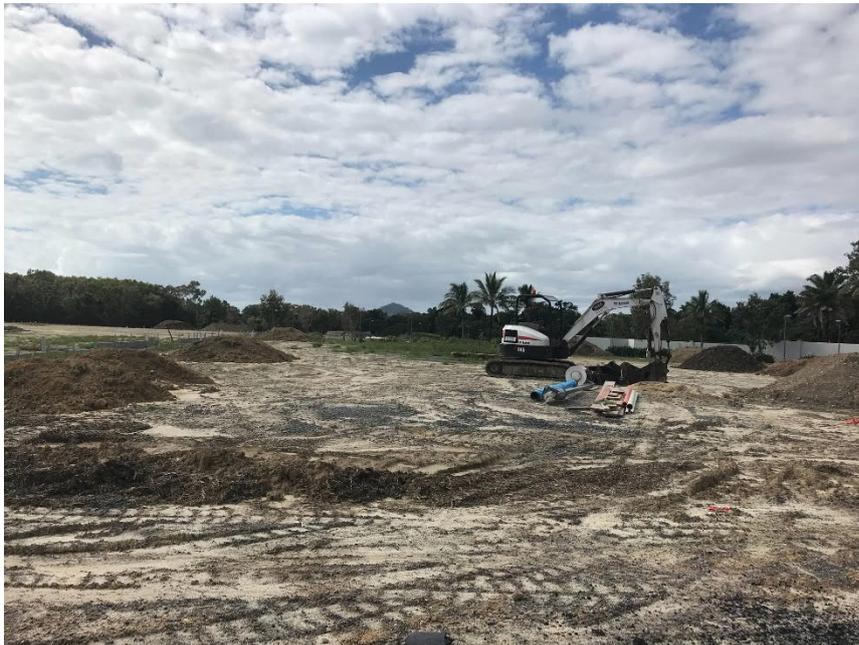
Photograph 1: General Appearance Lot 5, Argentia, Palm Cove

The location of the proposed development, Lot 5, Argentia, Palm Cove is a previously undeveloped lot levelled in preparation for development. The general appearance of the site is illustrated in photograph 1.
